Manhole Inspection Summary

Manhole # S69K__002MH

Insp Date: 1/30/08 11:15 AM

Location Address: **6705 O'Donnell St.**

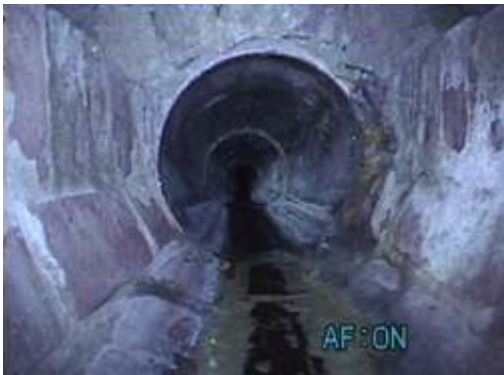
Defect 1

Cracked pipe seal 12:00-3:00 on incoming 6 o'clock

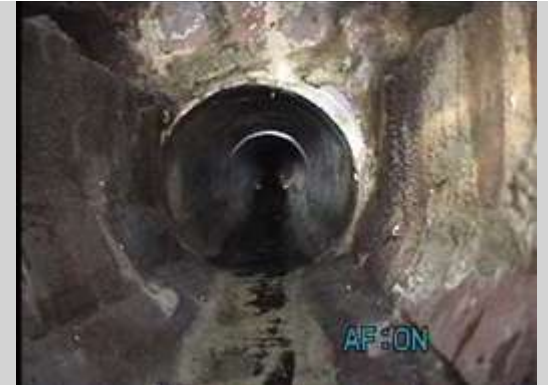
12 O'Clock Outflow

8 in. Circular Gravity Sewer
Pipe Out @ 12 O'Clock

Deposits: ☐ None ☐ Mud ☐ Sludge ☐ Debris ☒ Grease

Silt Depth: **0.25** (in.) Deposits Extent: **Light**

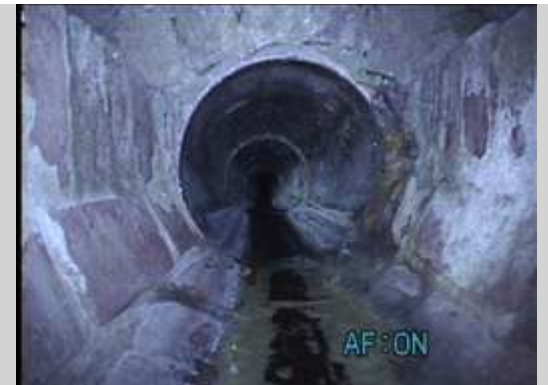
6 O'Clock Inflow

8 in. Circular Gravity Sewer
Pipe In @ 6 O'Clock

Infiltration: **None** Pipe Seal Cond: **Cracked**
